## BUSCH GEOTECHNICAL CONSULTANTS

### Certification Statement for Edoba Design Project, 5<sup>th</sup> Street, Port Orford, Oregon (APM 33-15-05DA, TL 8901)

**Geotechnical Report for the EDOBA Design Project,  
251 5th Street, Port Orford, Oregon  
(APM 33-15-05DA, TL 8901; Robertson)**

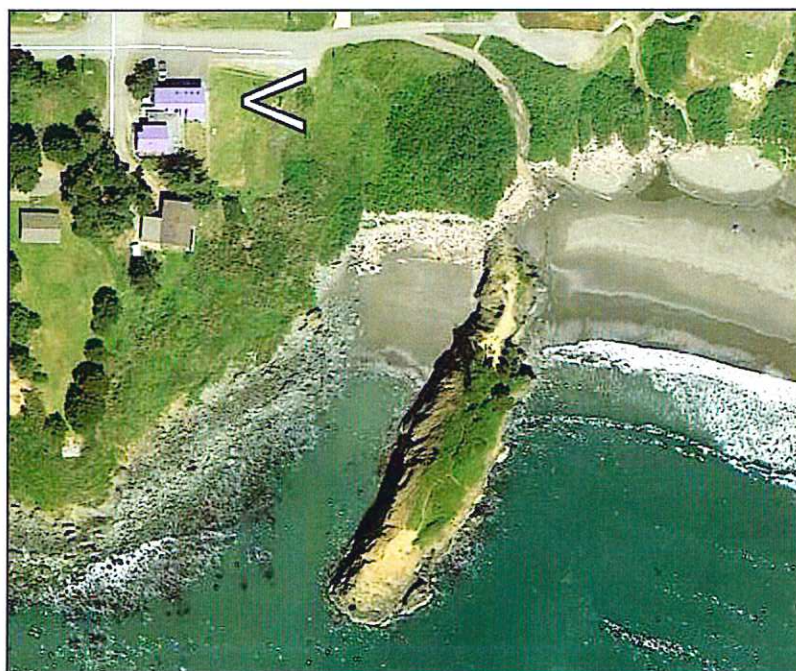
3) The elevation of the building area is nominally 75 ft MSL (above mean sea level) (see **Figure 2**). Tsunami run-up modeling by DOGAMI (2012) suggests that only the largest Csz earthquake could generate a tsunami that conceivably could inundate the site. The risk of inundation is essentially the same at all similar open-coast properties at about the project elevation. A near-source (Csz-generated) tsunami could erode lower elevation areas of the slope, which could cause upslope adjustments (i.e., rapid-rate creep, soil slips, perhaps others). However, the proposed foundation design would minimize the risk of damage.

**Figure 2. Project Topographic Map** (provided by owner). See Figures 3A, B, and C additional topographic information about the site vicinity. The site elevation is just barely above 75 ft. The buildings will be connected by a hallway (not shown).

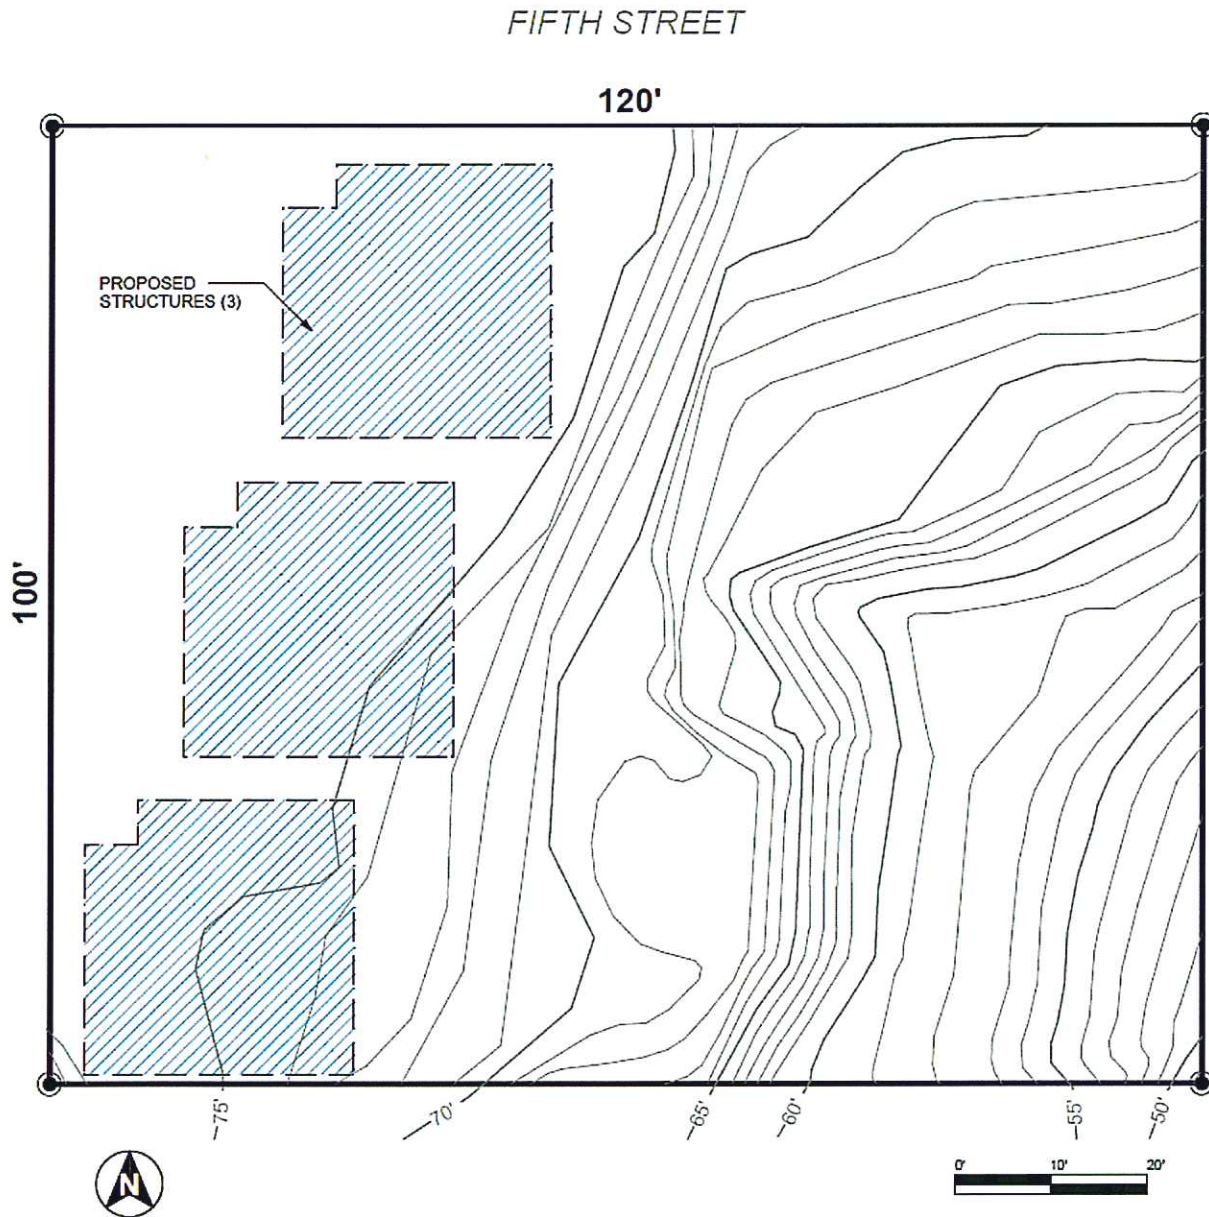
**Figure 3B.** The Robertson project footprints on the 2003 Stuntzner topographic base map. Current project buildings located and plotted to-scale by client. The buildings will be connected by a hallway (not shown). A comparison of the topography of the building area on this map with that of the project map of **Figure 2** indicates that grading occurred sometime after Stuntzner prepared the firm's map in 2003.

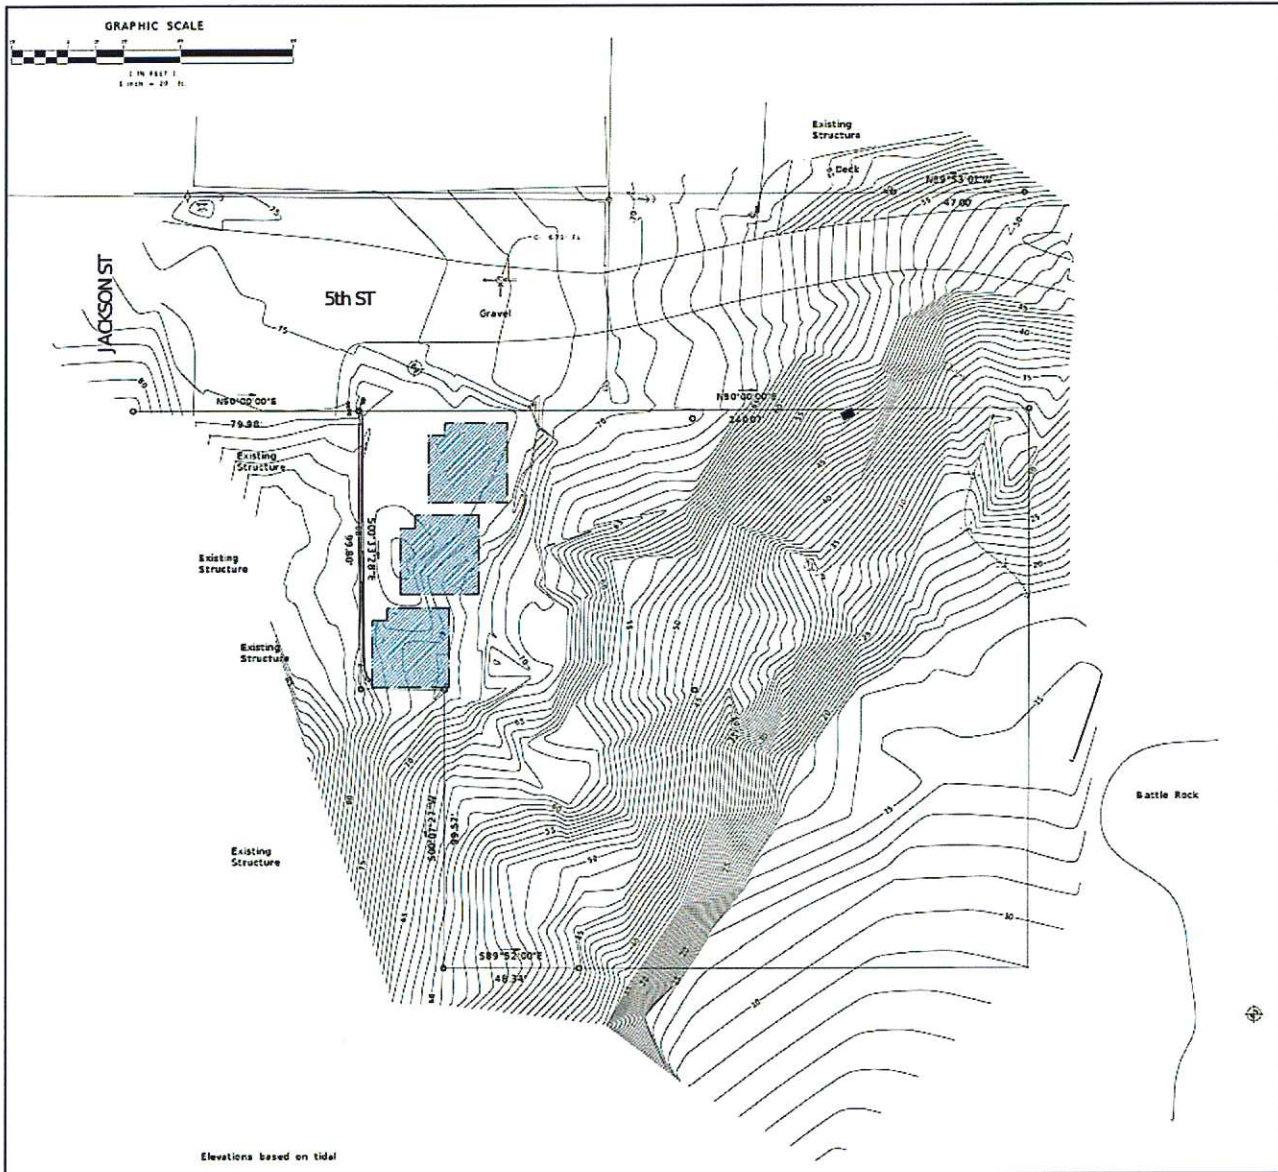
In 2003 TFGS completed a geologic report that Galli (2003) included as Appendix C in that firm's geotechnical report (Galli, 2003). TFGS supervised a drilling program that advanced 7 boreholes using a mud rotatory drill (see **Figure 3C** for the hole locations). TFGS also supervised the excavation of several backhoe test pits (no records exist). Galli included the borehole logs in his report as Appendix B (see **Figure 11**). The borehole logs are narrative (non-standard) so many kinds of information are missing. TFGS developed cross-sections that schematically show inferred contacts between the identified stratigraphic units. In 2005 when BGC began working on a draft report for the owner at the time (Gustafson), we prepared our own figures (**Figure 9** and **10**) based on our data (BGC, 1991) and data by TFGS (**Figures 6-8**). To simplify, the boreholes encountered fills soils and other "loose soils" that in places lay on top of denser marine terrace sediments that in turn overlie Otter Point Formation sandstone and mudstone bedrock.

**Figure 3C.** Stuntzner 2003 topographic map of the 2005 proposed Gustafson building area showing the location of subsurface investigations by BGC (1991) and TFGS (2003), XS and A-B-C series geologic cross sections respectively by TFGS (2003) and BGC (2005a), the proposed building footprint in 2005, and midden deposits (CITCRP, 2004). From BGC (2005a), recaptioned.

**REC 1.** Use a tied together reinforced grade beam foundation to support a structural slab. The foundations should consist of a perimeter grade beam poured neat close to on-grade to minimize the disturbance of middens (see **Figure 3C**). Each should have either linear or a "checkerboard" pattern of interior grade beams. Ideally each would be constructed as a monolithic pour, but this might not be practical for the middle and southwestern building. Use a standard underlayment beneath the slab. Please contact me if you need details.
